3809 SURFACE INSPECTION COMPLIANCE REPORT

Case Serial No./Name: UTU-068868

Operator: Thirstystone, Tucson, AZ

Project Description: Small Mine Plan-Surface Quarry (picturestone)

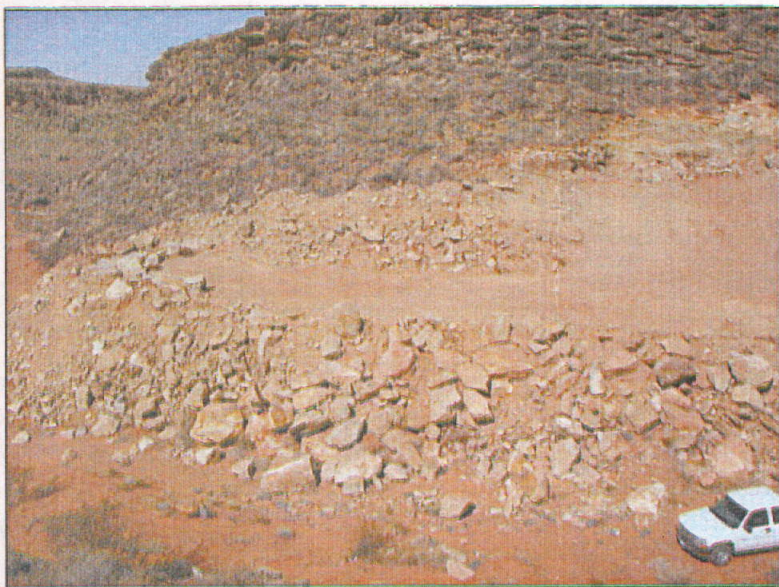
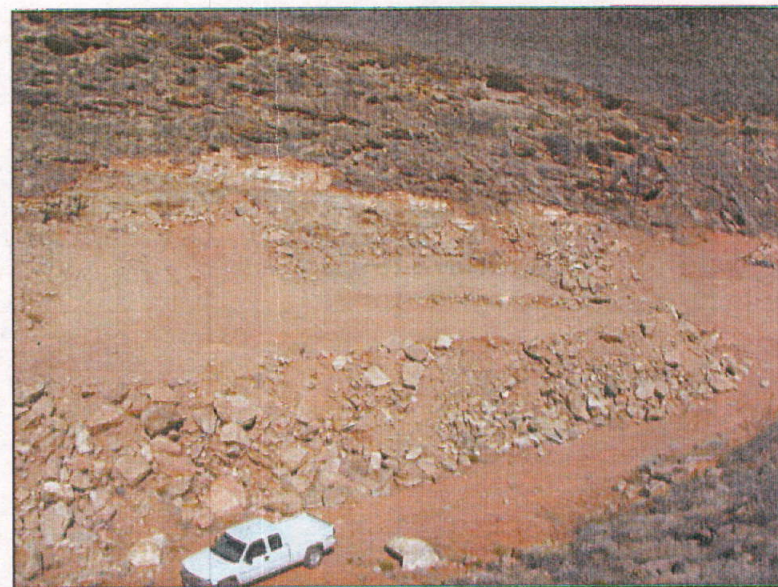
8 AUG 2002-UTU068868: (top left & right)-View of southern most disturbance facing west. (bottom left) Stockpiled boulders painted with numbers ranging from 8198-8300. (bottom right)-View of northern disturbance showing two working-face levels.

Minimal, if any, change from previous inspection that was completed by Ed Ginouves, CCFO geologist, on 2 August 2001. Boulders marked with red spray paint apparently stockpiled for transfer to processing site in Tucson, the headquarters of Thirstystone. Total disturbance is ~4.5 acres. Gate was broken and allowed public access into quarry area. The public is using the area as shooting range and dump. High-walls are a safety hazard and gate needs to be repaired.
